(Final Report, Revised May 23, 2023)

Condition Assessment
&
Reserve Fund Plan
2022

WHEELWRIGHT

Reston, Virginia

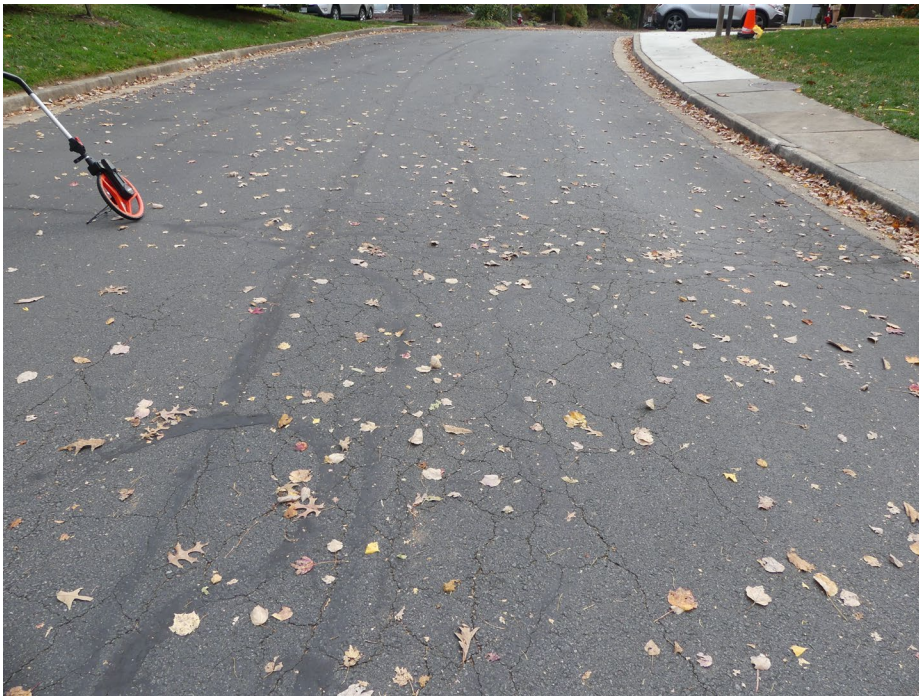
PHOTO #1

1.1	Asphalt Restoration Project	5,229	SY	\$20.00	\$104,580	18	2024	100%	\$113,114	2042	100%	\$229,148	2060	100%	\$464,211	This component includes asphalt drivelan es and parking bays of the community. Neither the depth nor the sub-base of the pavement could be visually determined. We understand that the pavement was milled with new compacted asphalt in 2009. It ranges from poor to fair condition. Major areas of deflected cracking (indicative of sub-base damage or insufficient asphalt depth) were observed on the drivelan es and parking bays. Management requested we set the next asphalt restoration project to 2024, as part of the final report. Restoration includes full-width profile milling to a possible depth of three inches with new compacted asphalt. Core sampling should be used to determine the depth and condition of the sub-base and pavement prior to restoration. Costs include striping, but not replacement of any inadequate sub-base.

The asphalt driveways and parking bays range from poor to fair condition. A moderate quantity of deflected asphalt (indicative of sub-base damage) was observed. Asphalt restoration, including milling and new compacted asphalt is scheduled mid-term.

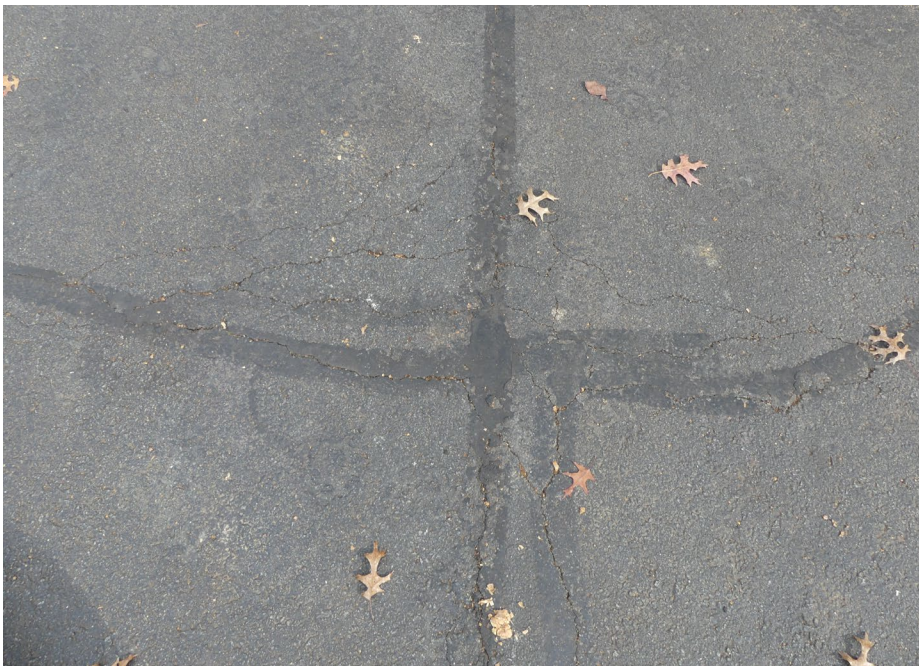
PHOTO #2

The pavements have been crack filled in past pavement maintenance cycles, but it has been several years since the last time it was completed.

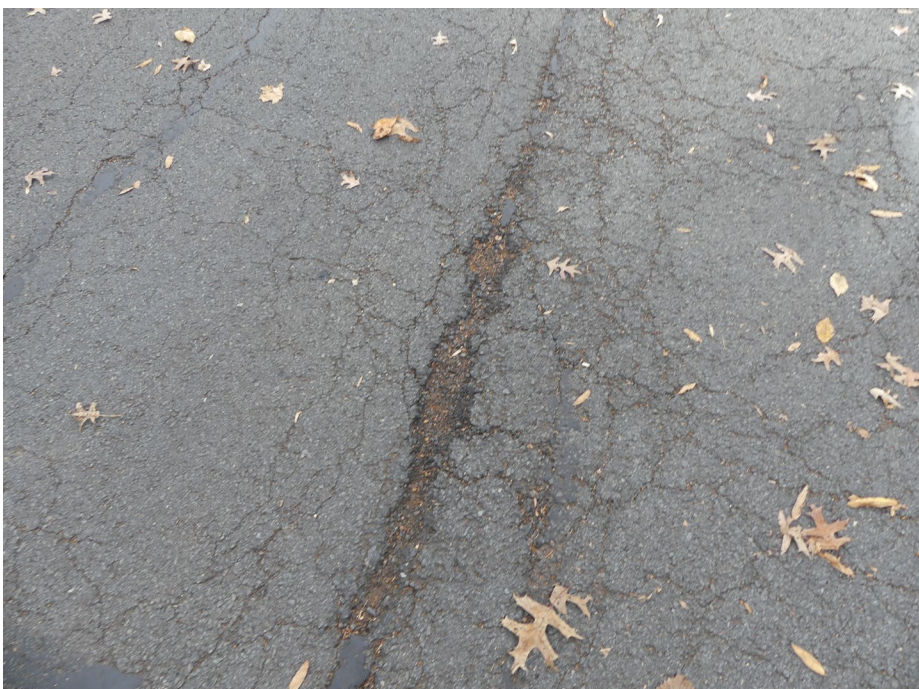
PHOTO #3

1.3	Asphalt Repair Allowance	1	LS	\$18,000.00	\$18,000	6	2030	25%	\$6,159	2036	50%	\$15,585	2042	100%	\$39,440	Approximately 2,614 square yards of deflected pavement (indicative of sub-base damage), and about 1,850 linear feet of longitudinal or transverse cracking were observed. Repairs are essential in order to achieve the projected remaining service life of the pavement. Full-depth repairs and crack filling are scheduled every six years throughout the study period, including the year of the asphalt restoration project. See the Asphalt Pavement Report, Section 8, for additional details.

We have scheduled the next cycle of pavement maintenance near-term, which should include full-depth repair of the deflected asphalt (pictured left), crack filling, and seal coating. Pavement maintenance should be accomplished every six years.

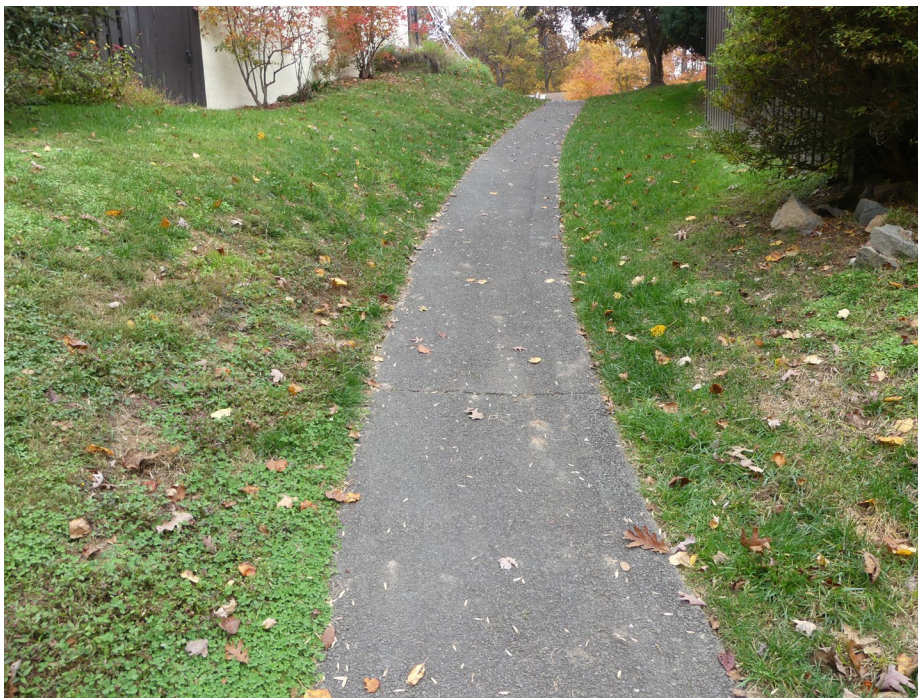
PHOTO #4

1.4	Asphalt Footpaths	303	SY	\$40.00	\$12,120	15	2028	100%	\$15,336	2043	100%	\$27,619			Three asphalt footpaths generally 5' in width are constructed throughout the community. The footpaths are in generally continuing good condition. We did not observe any major transverse cracking. Any trip hazards or hazardous surface deficiencies should be addressed expeditiously to prevent personal injury.																		
2 CONCRETE COMPONENTS

The asphalt footpaths are in overall good condition. Any surface deficiency tripping hazards such as heaved roots, etc. should be mitigated expeditiously to prevent personal injury.

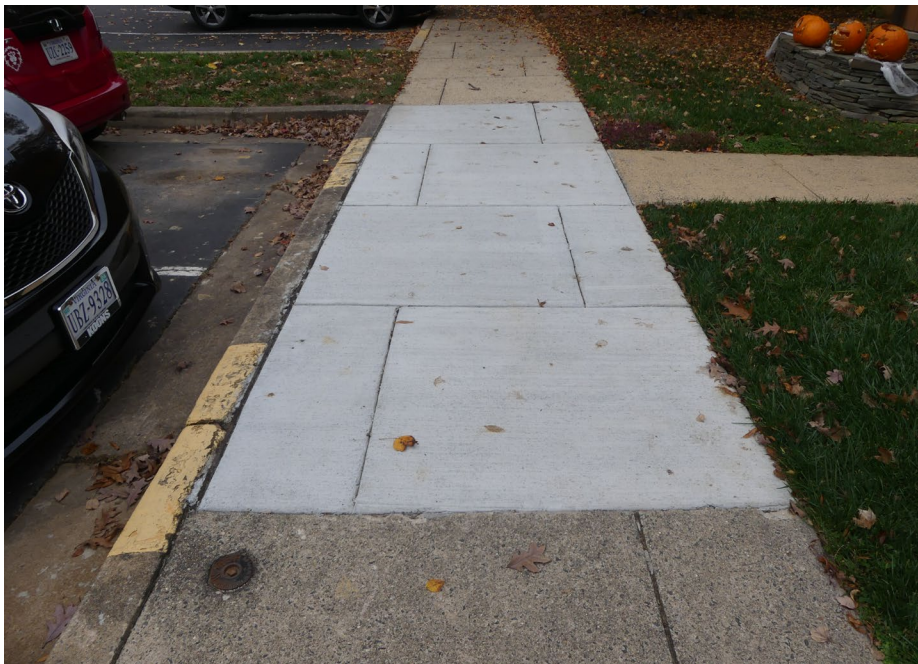
PHOTO #5

2.1	Concrete Sidewalks	7,296	SF	\$13.00	\$94,848	5	2023	6%	\$5,919	2028	4%	\$4,801	2033	3%	\$4,380	Concrete sidewalks, generally 4' and 5' wide, are present on one or both sides of streets within the community. Their thickness could not be visually determined. They range from fair to generally good condition. About 425 square feet (5.8% of the total area) is either cracked, settled or heaved between sections. We have not scheduled replacement of all sections with lesser surface defects. Severely scaled sections will tend to deteriorate more quickly over time and should be replaced in each replacement cycle. Cyclic repairs are scheduled, as full replacement at one time is not appropriate or anticipated. Concrete repairs are scheduled to coincide with work on other concrete components to take advantage of economies of scale in packaging concrete restoration work. The Board should be aware that repairs to small quantities of concrete may be more costly because of the difficulty of attracting competitive bids for small projects, which may not meet contractor minimums. Any trip hazards or hazardous surface deficiencies should be addressed expeditiously to prevent personal injury.

2.2	Concrete Curbs & Gutters	3,110	LF	\$40.00	\$124,400	5	2023	3%	\$3,881	2028	2%	\$3,148	2033	2%	\$3,830	The drivelan es and parking bays are lined with standard-profile, cast-in-place, concrete curbs and gutters. They range from fair to generally good condition with about 2.2% of the length having transverse cracks or settlement. We observed approximately seven damaged sections, which should be replaced. Minor chips usually do not justify replacement. Cyclic repairs are scheduled, as full replacement at one time is not appropriate or anticipated. Curb repairs are scheduled to coincide with work on other concrete components to maximize economies of scale. Any trip hazards or hazardous surface deficiencies should be addressed expeditiously to prevent personal injury.

The concrete sidewalks, courtyard concrete, and the curbs and gutters range from fair to good or new condition. Any settled or heaved concrete sidewalk panels should be mitigated expeditiously to prevent personal injury.

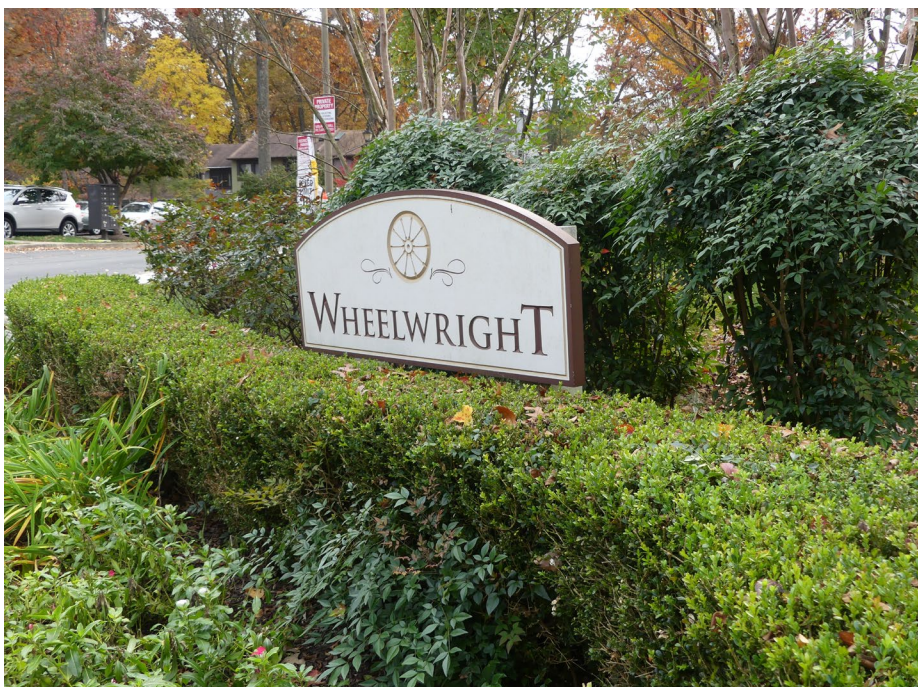
PHOTO #6

3.1	Carved Wood Entrance Sign	1	EA	\$2,500.00	\$2,500	20	2032	100%	\$3,701	2052	100%	\$8,108				A painted, MDF (Medium Density Fiberboard) community name sign is installed at the entrance to the community. The sign is approximately five feet long and three feet tall and is attached to two 6 x 6 painted posts. We did not observe any irrigation systems or lighting. The sign is in fair condition.

The MDF (Medium Density Fiberboard) entrance sign is in fair condition. Repainting the sign and posts will improve appearance and help to maximize its service life.

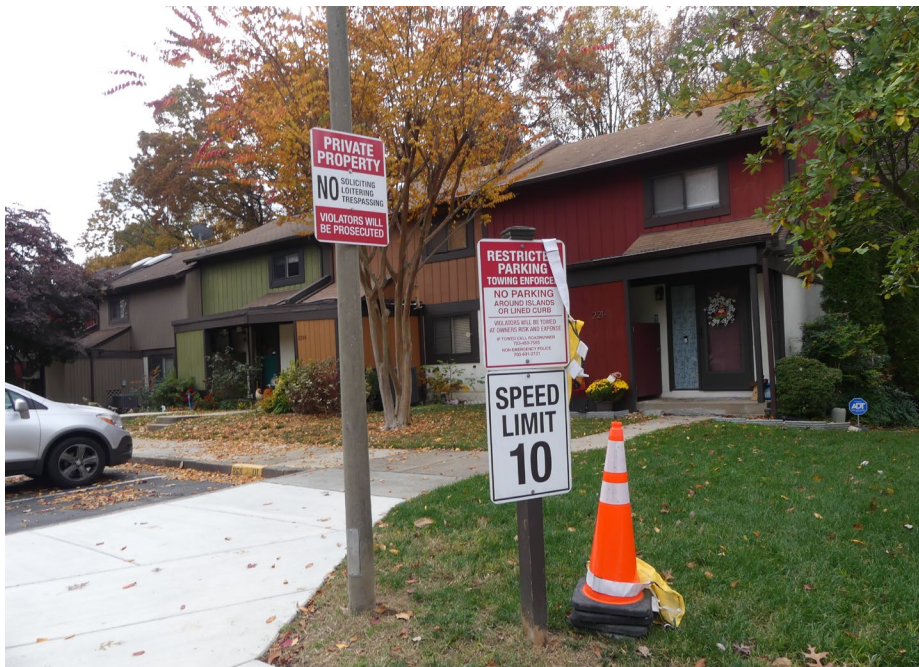
3.2	Street and Informational Signage	5	EA	\$175.00	\$875	20	2032	100%	\$1,295	2052	100%	\$2,838				Standard metal traffic, parking and access control signs, typically 12" by 18" and mounted on perforated metal posts, are located throughout the community. Other signs, such as stop signs, are mounted on 4" by 4" timber posts. A total of approximately five signs are installed. Posts and signs appear to be in good to fair condition.

PHOTO #7
The street and informational signage ranges from fair to good condition.

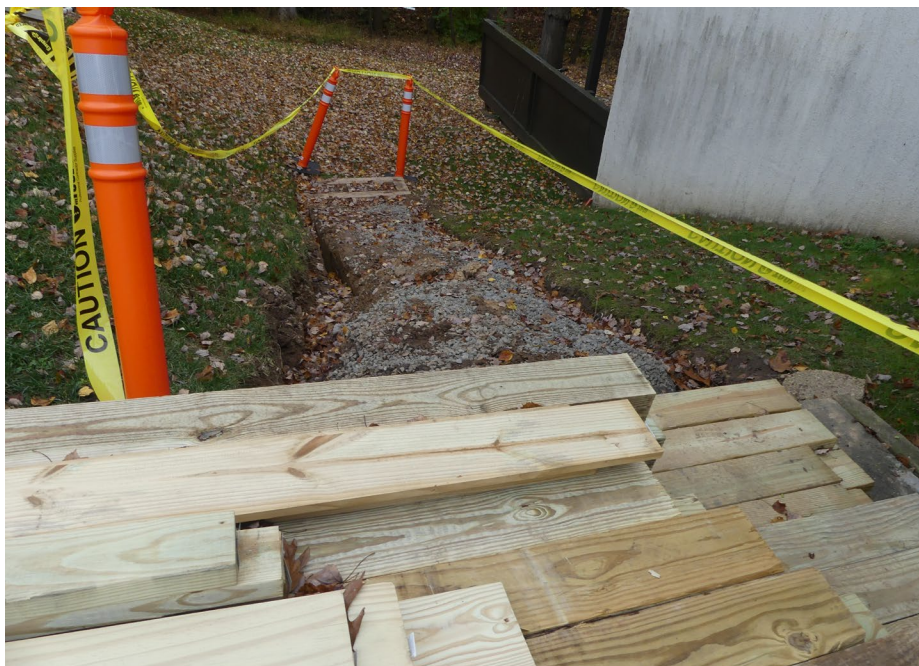
3.4	Wood Steps	1	LS	\$4,000.00	\$4,000	20	2042	100%	\$8,764	2062	100%	\$19,204				A set of pressure-treated wood steps were in the process of being replaced near Unit 2263 Wheelwright Court. We understand that the original steps were at the end of their service life and are being replaced by the Board/homeowner volunteers in the community.

PHOTO #8
We understand that the set of wood steps in this location were removed and are currently being replaced. The Board and homeowner volunteers are rebuilding the steps.

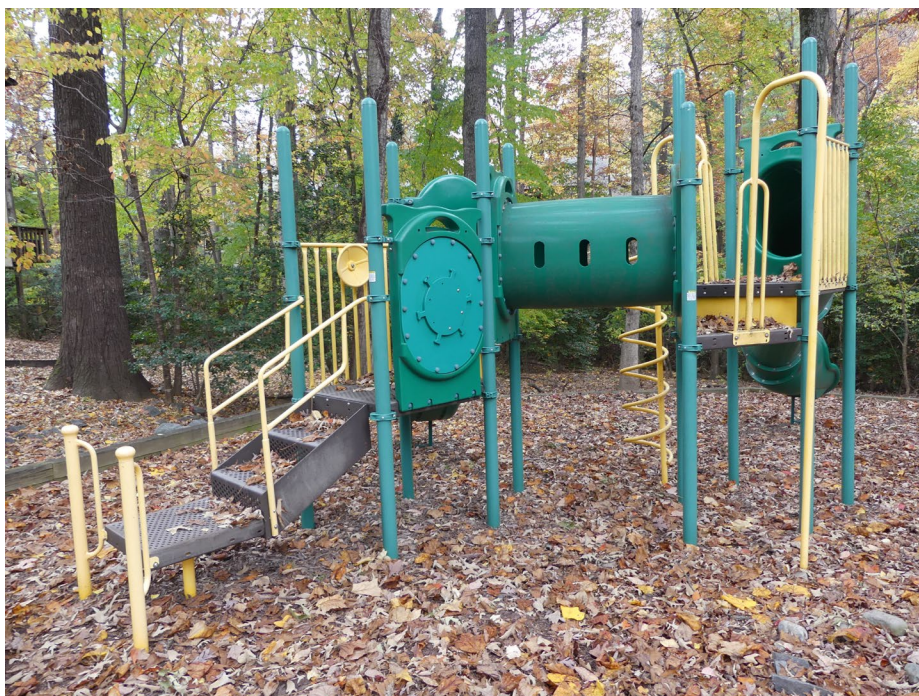
3.5	Tot Lot & Outdoor Furniture Allowance	1	LS	\$38,000.00	\$38,000	15	2030	100%	\$52,006	2045	100%	\$93,659				One tot lot is located within the community. Equipment consists of 124 linear feet of wood borders, two wood and metal benches, a trash receptacle, and a 10 post play module with climbing equipment and two plastic slides. All equipment appears to be in good condition. An additional seven wood benches are installed around the community, which also range from fair to good condition. Frequent, periodic safety checks of all components should be conducted to prevent personal injury. Replacement costs are based on replacement with U.S. Consumer Product Safety Commission (CPSC)-compliant play modules.

PHOTO #9
The tot lot play module and outdoor furniture range from fair to good condition. We did not observe any major safety issues.
